# 디스코클럽 火災現場 컬러畫報

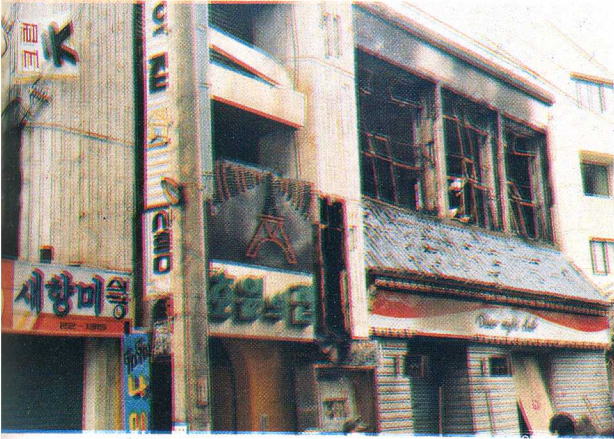
◀ 發火建物

Front scene of the discotheque.

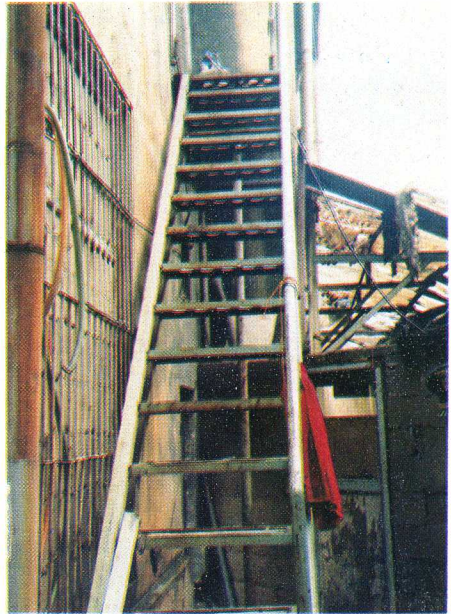
▼ 2層 초원의 집 發火部位 天井  
 붉은 벽돌로 된 건축물은 화장실로서,  
 화장실 上部에서 發火하였다.

The ceiling of the second floor from where the first ignition seemed to start.

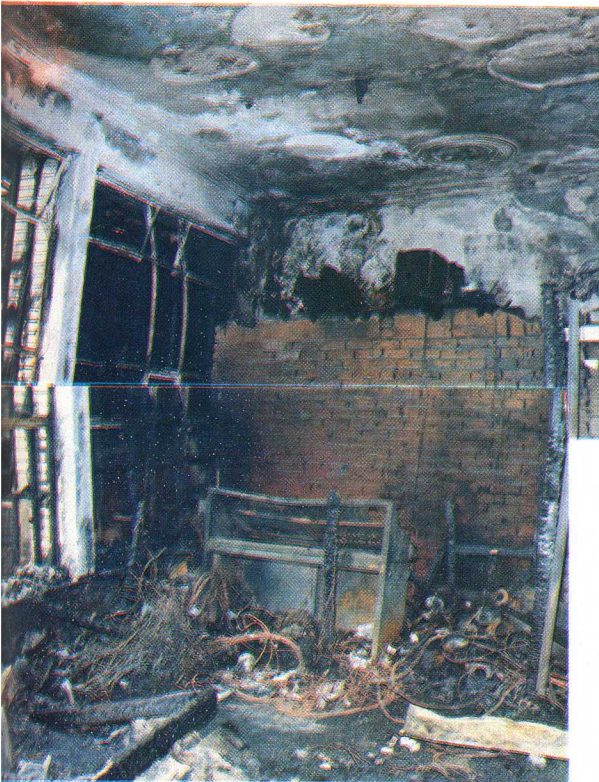
▲ 建物北側의 非常階段

非常口가 의자 등으로 막혀 있어 이  
 階段은 利用되지 못하였다.

There was an another stairway, besides the main stairway. However, the door to this emergency stairway from the inside of the second floor disco club "Prairie house" had been blocked up with chairs, tables, and other things. Consequently, the rescue operation was delayed to break down the door.

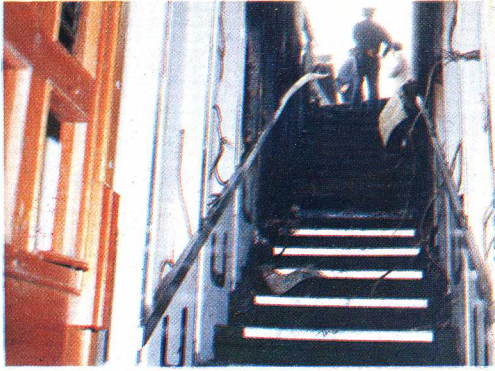
▲ 많은 人命被害를 낸 主階段 ▶

階段室内에 可燃内裝材가 設置되어 階段幅이 좁아졌을 뿐 아니라 延燒擴大要因이 되어 人命被害를 加重시켰다. (階段 non-slip이 희게 보이는 部分에서부터 50~60餘名이 넘어져 거의 階段室을 막을 정도로 쌓였으며 이 때문에 많은 壓死者가 發生하였다.)

Most of the victims were found at this main stairway.

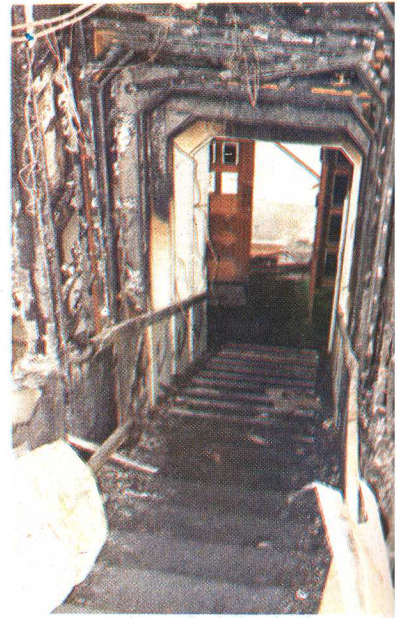
◀ 燒盡되어 내려 앉은 2層의 바닥과 天井

Collapsed ceiling and floor of the second floor

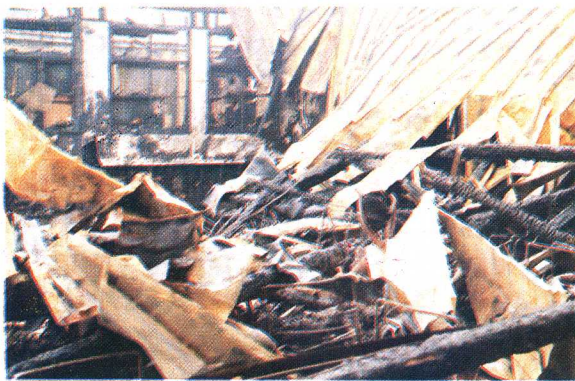
무대부 周圍의 바닥 燒損狀態 ▶

Damaged floor around the stage of the second floor.
